fire risk assessments

shepherds court and bush court, charecroft estates off shepherds
bush green, london w12 8ra

October 2009

hunters

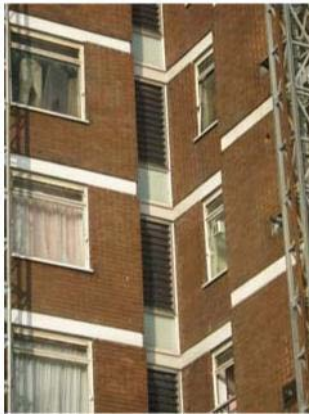
Other vulnerabilities are caused by the presence of the riser ducts running vertically through the building. The permanently open louvres in the lobbies will permit smoke to vent and fresh air to be drawn in. This beneficial effect could be impaired by particular atmospheric conditions, such as wind or dense fog that might cause back draughts which could allow the smoke to transfer through the riser shaft from one floor and out into another. There is currently no mechanism in place for preventing this.

The external, translucent, louvres are of plastic construction. The plastic will melt, and may burn, in a fire. Adjacent to the louvres are windows to flats. These windows are centre-pivoted and open fully, and some contain extract vents. A fire in a lobby could thus spread via the louvre and adjacent window into a flat.

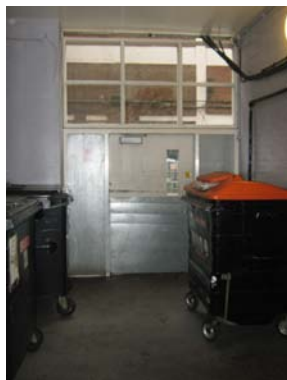
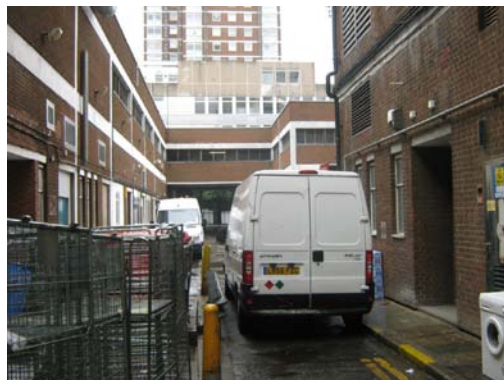
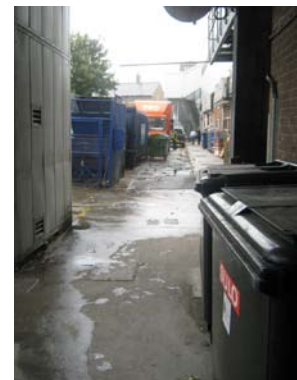
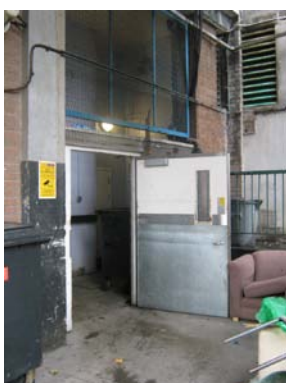
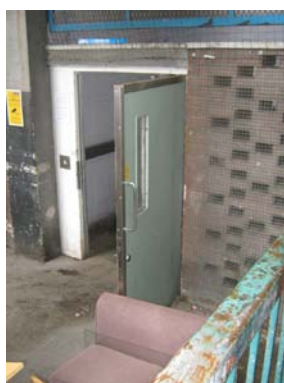
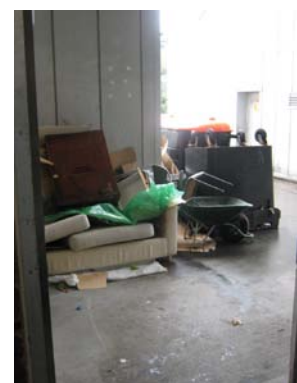
The conditions at the back fire escape in October 2009 were found to be little changed from those described in May 2007. There is still a considerable quantity of flammable waste close to the rear exit doors and the route to a place of safety is not clear, as is evident in the photographs below:

The Recommendation is to clear all of the bins and waste from around the exit doors and discuss with Residents the fire related implications of leaving waste in the vicinity of the escape routes. Caretaker or Concierge should ensure that other users of the Service Yard leave escape routes free for Residents.

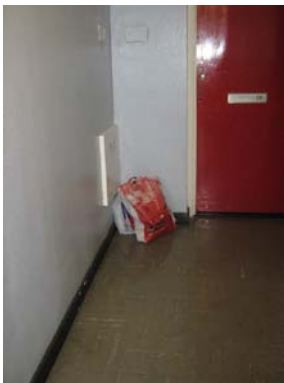
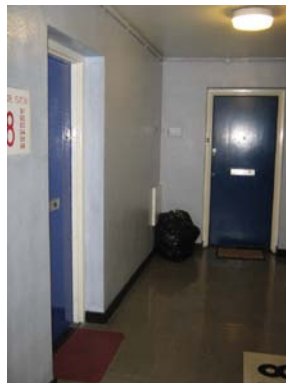
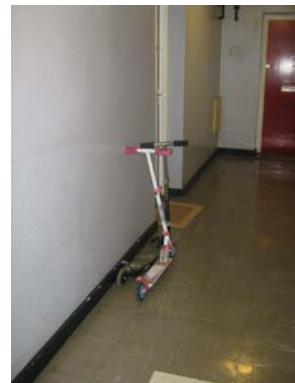
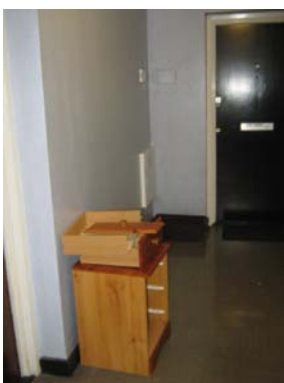
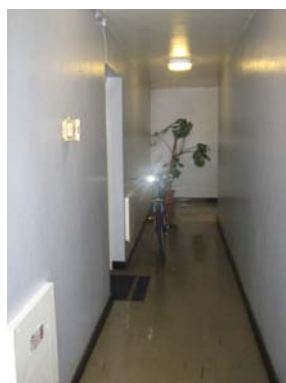
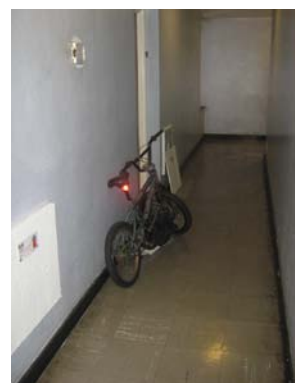
There was very little evidence of escapes routes being blocked; sample photographs of the condition of Escape Routes are shown below:

The Recommendation is to discuss with residents the fire related implications of using the communal areas as a dumping ground for their unwanted items and waste

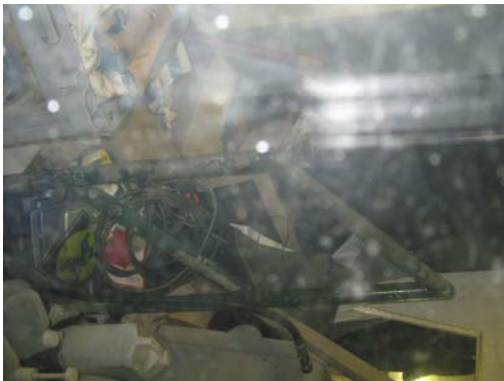
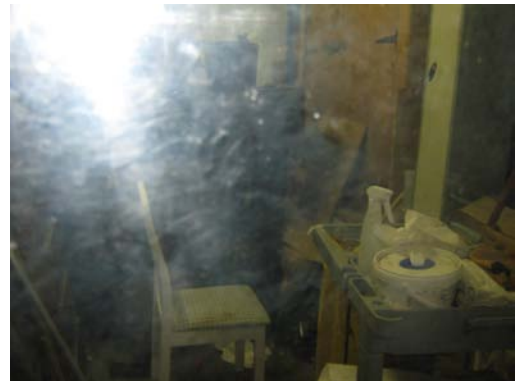
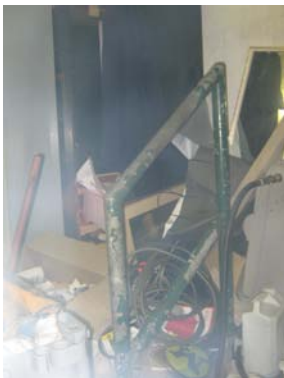
The Caretaker's Store does have an excess of flammable materials untidily stored and would benefit from the introduction of improved housekeeping. Photographs of the store are below:

The recommendation is to implement a regime of improved housekeeping to ensure that the condition of the Stores does not present a fire hazard.

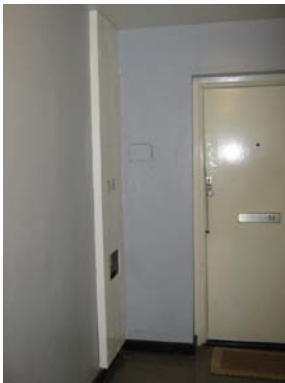
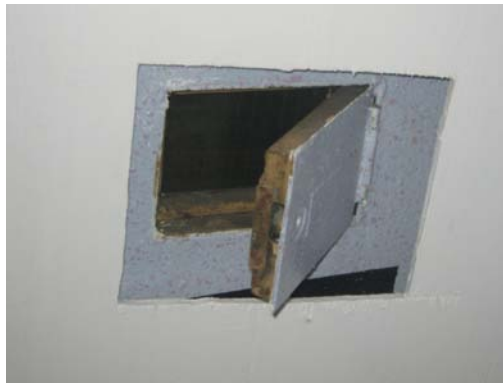
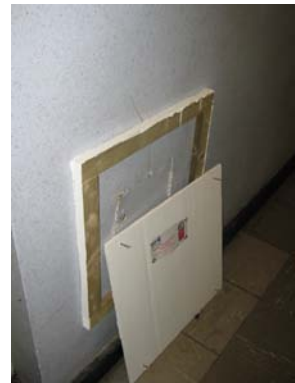
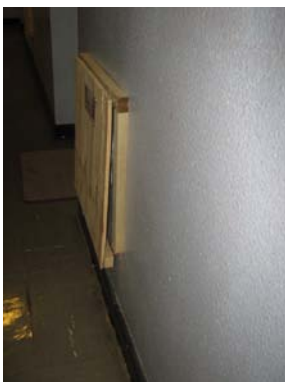
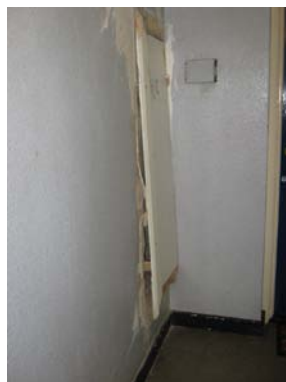
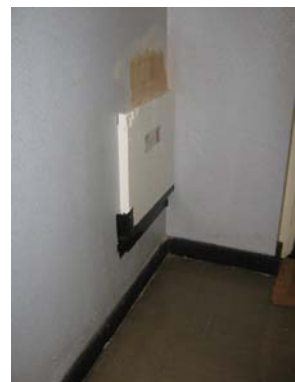
Due to the possible presence of asbestos in the risers, and thus to prevent access, timber covers have been screwed over the metal access hatches. Because of the timber covers it has not been possible to establish the condition of most of the access hatches to the risers. However, where there were a few loose timber covers it appeared that the metal hatches were not locked shut and it is surmised that many could be in this condition. The fire protection, therefore, is being provided by timber board which should be replaced with a fire resistant material.

Photographs of some of the timber covers are shown below:

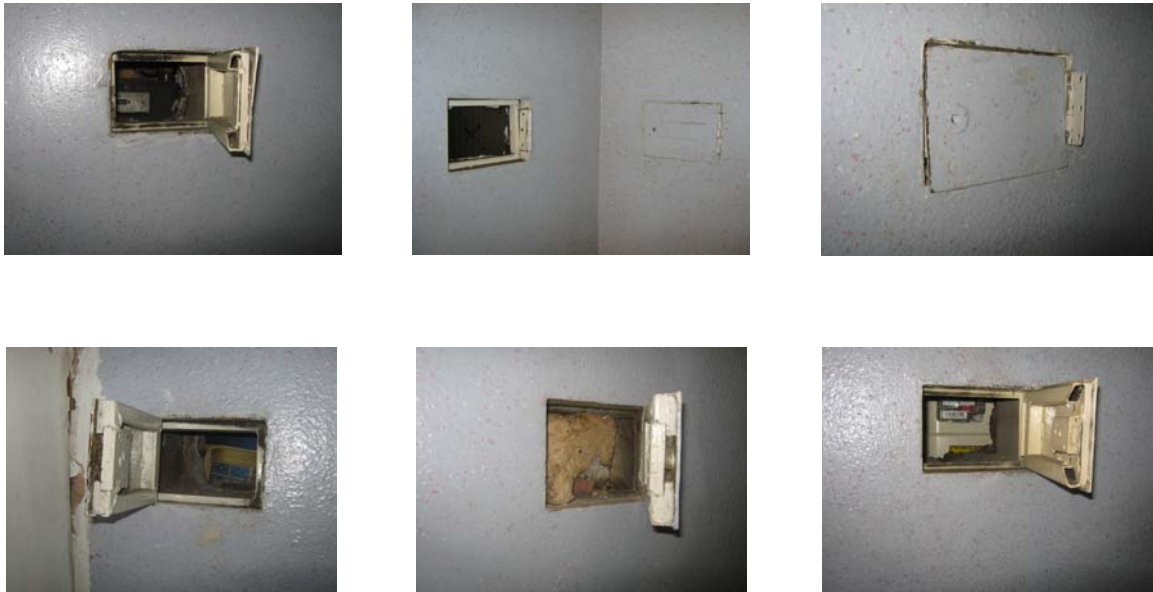
Some of the gas meter viewing windows have been broken and a small number had missing metal hatch covers. Where the glass was missing, many of the openings had been stuffed with paper to create a seal. All of the hatches have been overpainted and thus the hinges and, particularly, the locks function badly; there were also some missing locks.

Examples of damaged or missing gas meter viewing windows are shown below::

The Recommendation is to replace the broken Georgian wired glass windows and metal cover doors to the gas inspection windows, to replace missing or damaged locks and to make good all those that are not functioning due to the build up of paint.

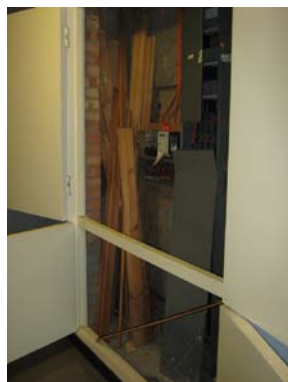
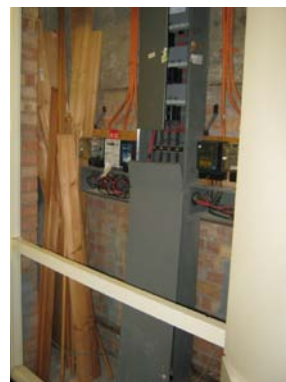
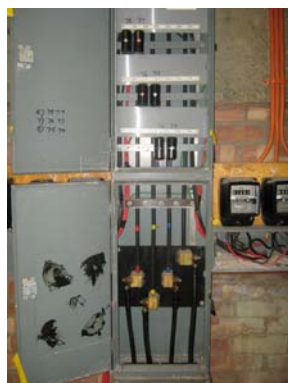
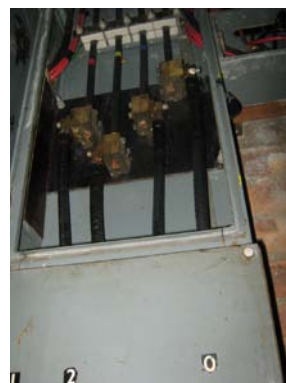
It does not appear that the recommendations have been followed and photographs, below, the first of each pair having been taken in early September 2009 and the second in early October 2009, illustrate the lack of improvement.

The Recommendation is to implement the Recommendations of the Meter Survey Report issued on the 10th September 2009 without delay in order to protect Residents both from fire hazards and electrical hazards.

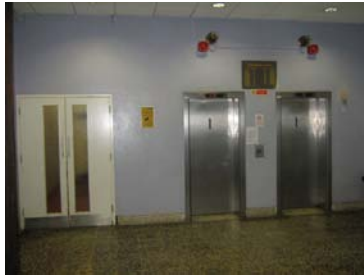
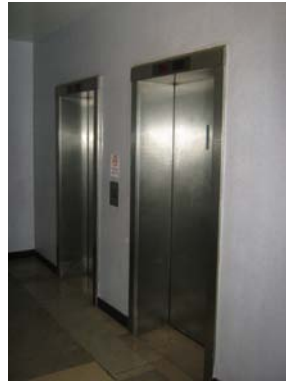
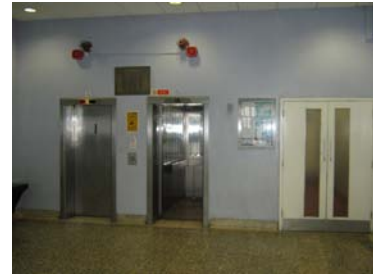
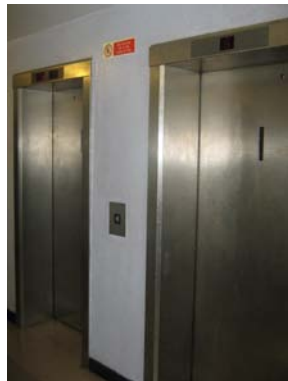
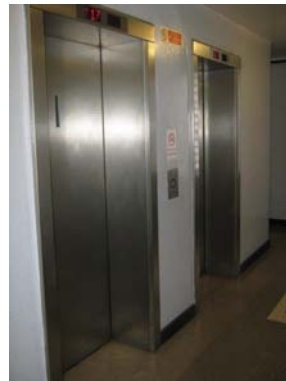
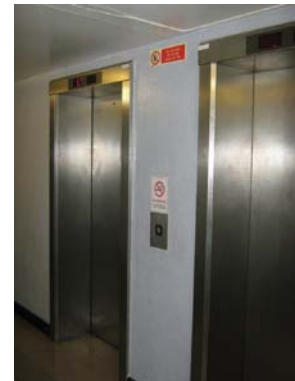
There are no signs within the lifts advising what to do in the event of a fire.

The Recommendation is to incorporate emergency instructions as part of the wider signage upgrade recommended under Recommendation 4

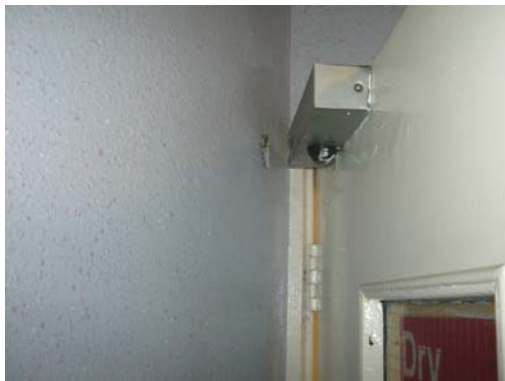
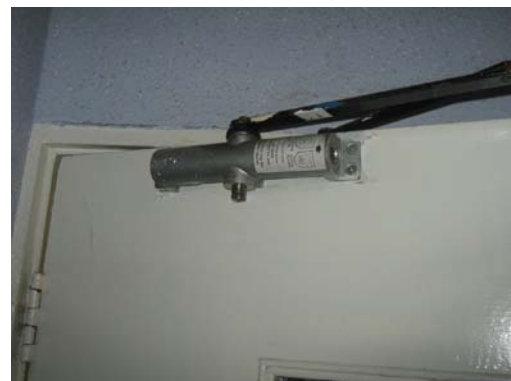
Some of the doors have had face-fixed door closers installed to replace the original concealed closers. The large rebates in both door and frame which accommodated the original closers will need to be filled with hardwood inserts. Some closers have been face-fixed onto the wrong side of the doors and have impact damaged the adjacent wall.

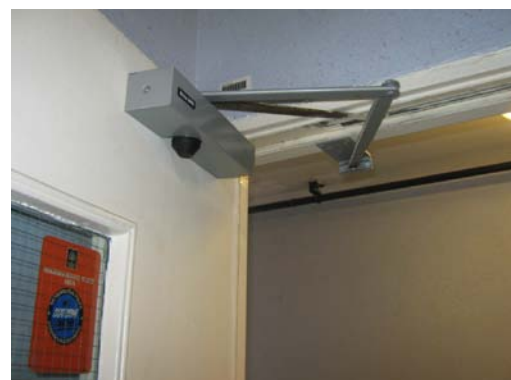
Not all original closers have been removed, thus some doors have 2 closers attached.

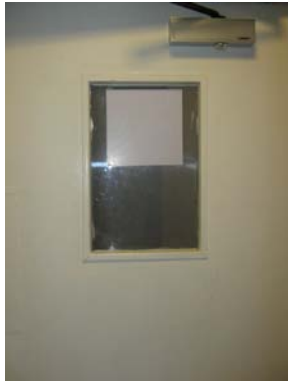
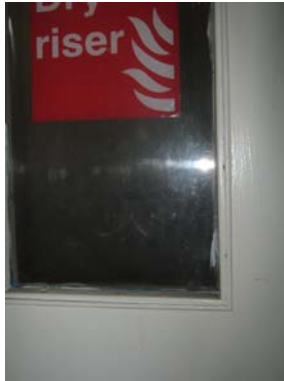
The doors have a glazed vision panel at high level which is neither compliant with Part M of the Building Regulations nor with BS8300. To achieve compliance a second panel will be required at low level. Cutting an additional panel into the old door of doubtful provenance could further compromise its fire integrity.

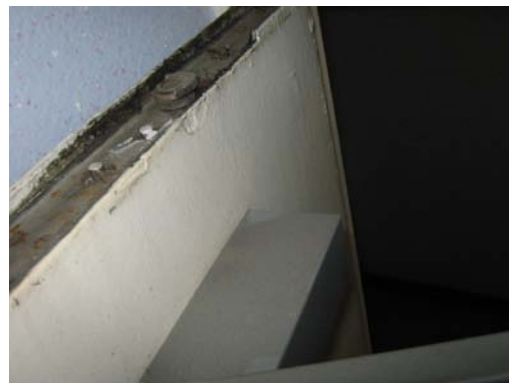
Where original closers have been removed there are rebates in both the tops of doors and in the heads of doorframes. Some of these have been inexpertly filled, others left

and, in at least one instance, part of the door closer remains in the top of the door. In any renovation of the doors, these rebates will need to be made good.

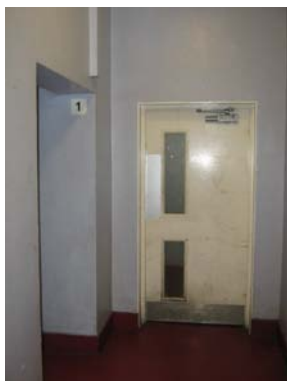
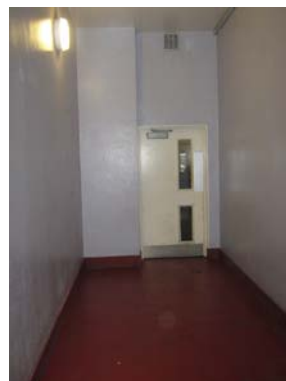
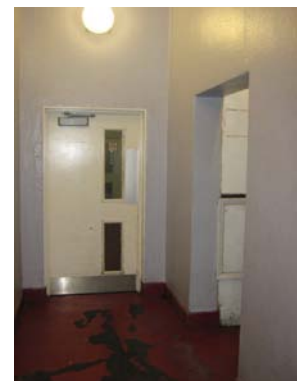
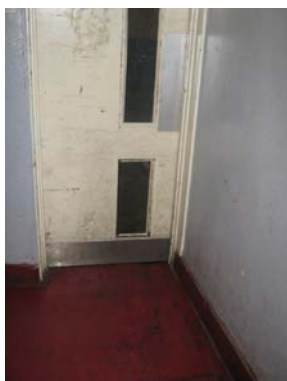
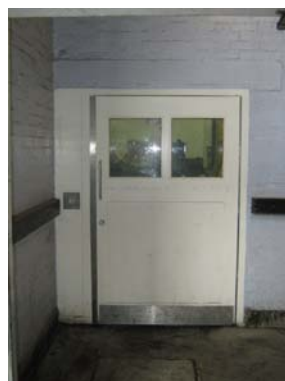
Between the bottom of the stairs and the lift lobby is a set of double opening doors. These are in serviceable condition but it is unlikely that they will provide fire or smoke protection to the escape route. They can be upgraded by the fitting of smoke seals but, as with the lobby/stair doors; no guarantee of performance can be given. These doors should, therefore, also be considered for replacement by a new doorset.

On the escape route between the bottom of the stairs and the rear exits are single panel, single swing doors with double vision panels which similarly have no obvious fire or smoke retaining properties. These should be either upgraded as described above or, better still, replaced by fire rated and certified, complete doorsets.

The final exit fire door at Bush Court has a missing bottom glazing panel; this must be replaced to maintain protection against fire and smoke entering the building from the Bin Store and Service Yard

The glazing in the door to the Caretaker's Room/Store adjacent the rear exit is not fire rated. This should also be replaced to protect the escape route in the event of a fire starting within the Store.

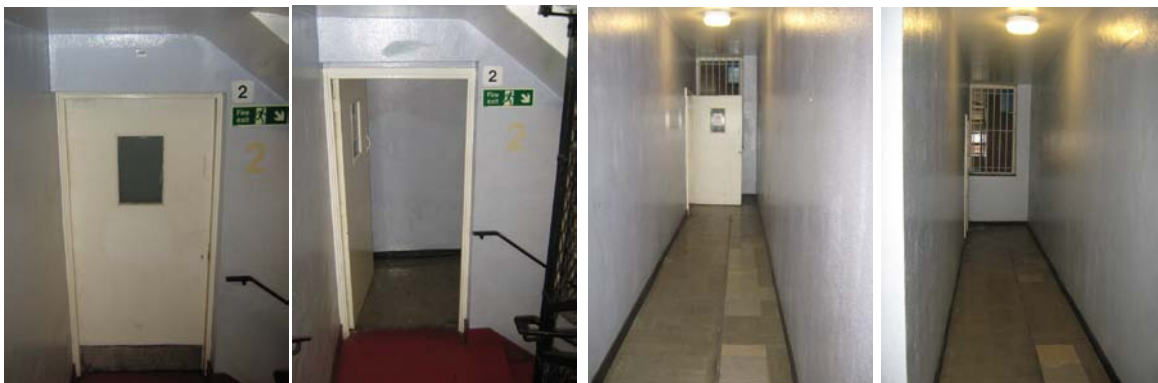
Consideration should be given to the possible usefulness of these doors in the event of a fire; could they be used to escape onto the Amenity Deck, and thence to the other Court, if there is a fire at the bottom of the stairs thereby preventing flight to a place of safety or, could the walkway and door to the staircore offer safe escape from the Amenity Deck in the event of a fire starting there?

Presently the doors offer no such use in an emergency and do not prevent the passage of smoke or flames. When upgrading these doors, it would be useful to consider how their use could help Residents in the event of a fire and then fit the appropriate ironmongery, taking into account the best direction of door-opening, to facilitate their use.

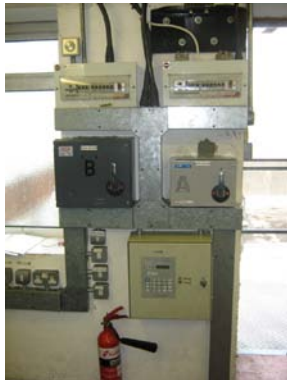
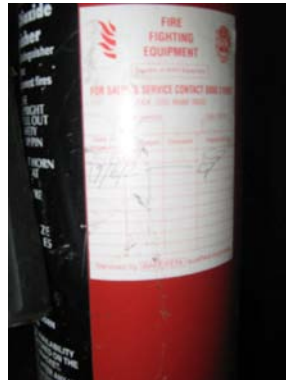
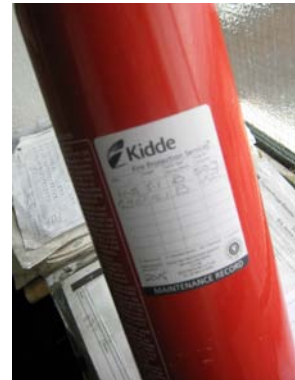
During the current survey, fire extinguishers were noted in one of the rooftop Tank Rooms and both Lift Motor Rooms.:

All three extinguishers show no evidence of having been checked within the last year; the dates of last checking shown on the extinguishers being 19th June 2000, 2nd November 2005 and 6th March 2007.

The recommendation is to (as previously recommended in Recommendation 5) initiate procedures for ensuring that fire extinguishers are annually serviced and then regularly checked to ensure that they are still present and fully able to function.

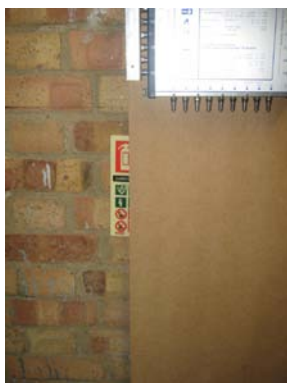
Furthermore, the extinguisher in the Lift Motor Room in Shepherds Court appeared to be empty.

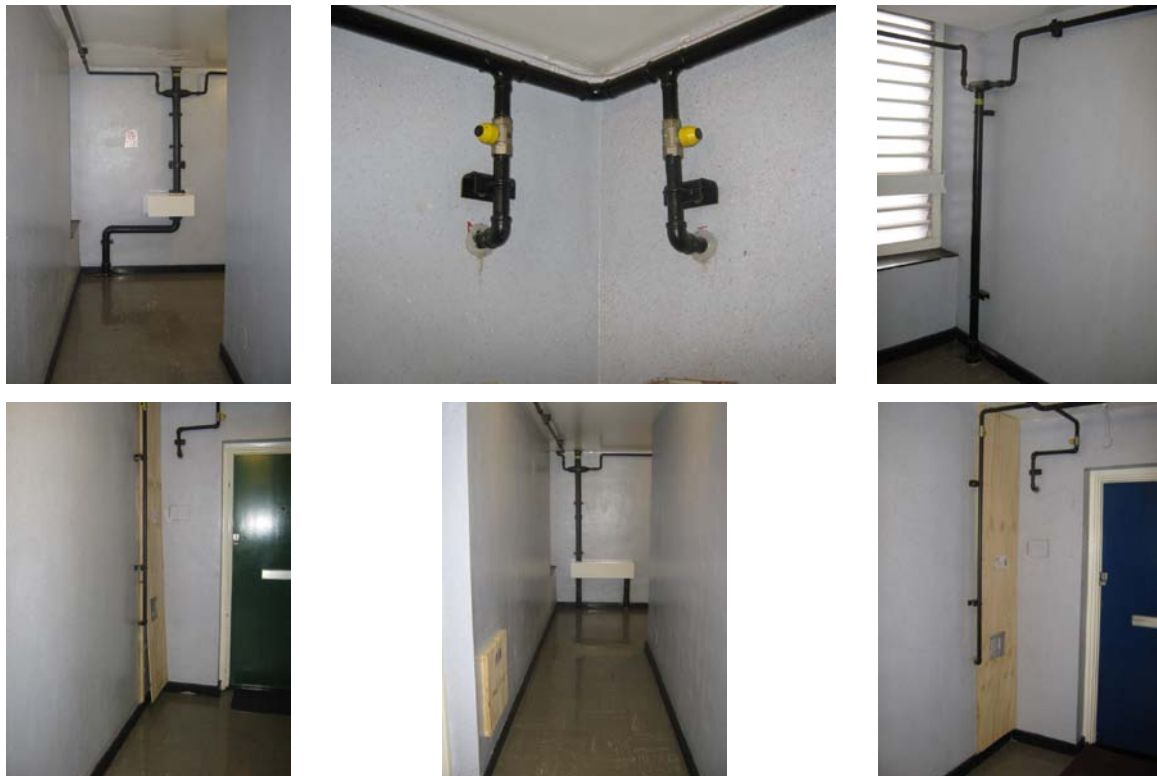
Thus the gas pipework is on show – and possibly vulnerable to vandalism or arson - and less protected from the effects of a fire in a corridor.

The recommendation is to seek guidance from a Fire Engineer, or the LFB, as to the safety implications of having exposed gas pipework, albeit relatively new and installed in accordance with modern standards, in escape corridors and to follow whatever advice they give.

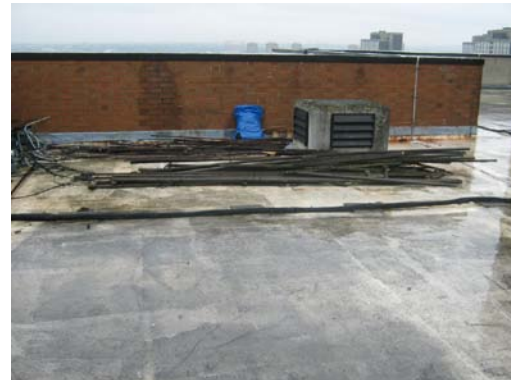
At the time of this inspection there was very little rubbish on the roof merely some old conduit and lengths of timber.

The recommendation is to consider fire detection within the lift motor room and to ensure that the roof is completely cleared of all materials and rubbish.

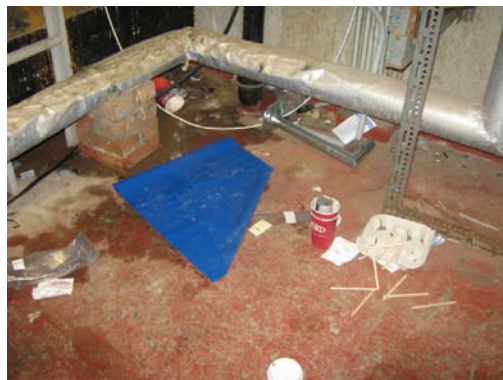
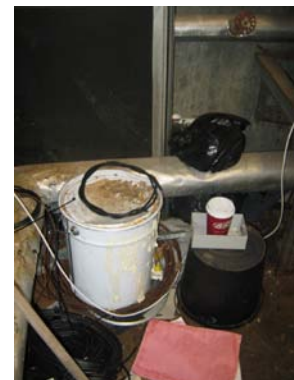
What is not mentioned in the original Risk Assessment is the condition of the Tank Rooms above the staircores. Within these rooms is the installation for satellite TV reception, and for transmission of data by radio, and large quantities of rubbish with other flammable and combustible materials scattered about.

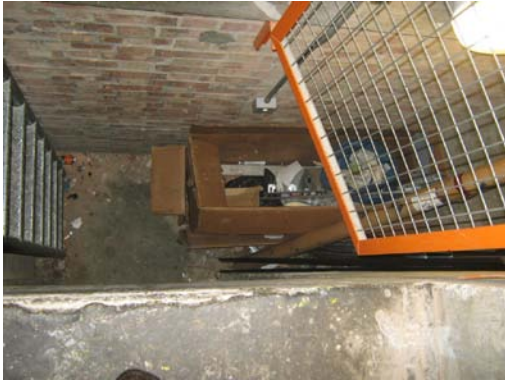
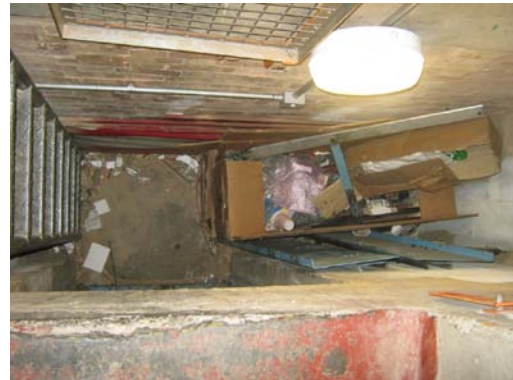
Access to the roof is gained via a door at the top of the internal staircore leading to a small lobby from which a cat ladder provides entry to the Tank Room. In both Courts, this lobby was full of packaging, odd materials and rubbish.

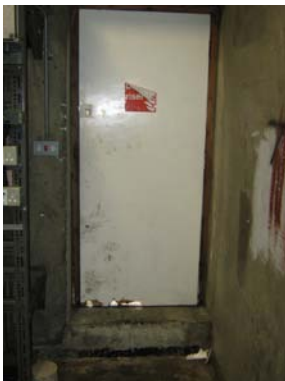
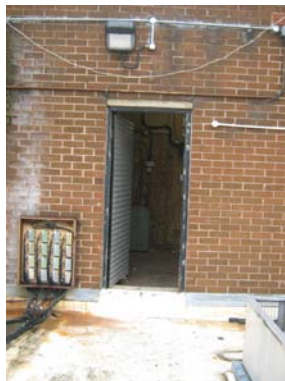
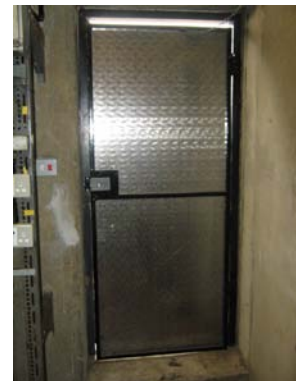
The doors leading out from the each Tank Room to the roof were poorly fitting and not fire proof. Both should be replaced and fitted with appropriate safety signage to ensure that they are not locked or obstructed in the case of an emergency.

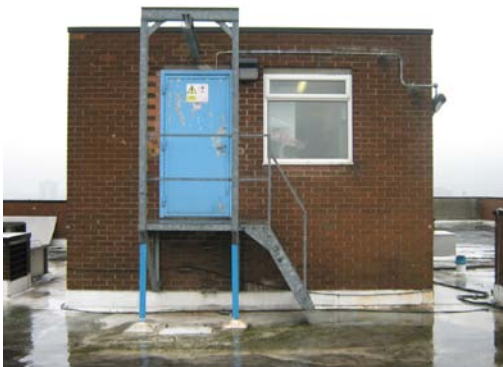
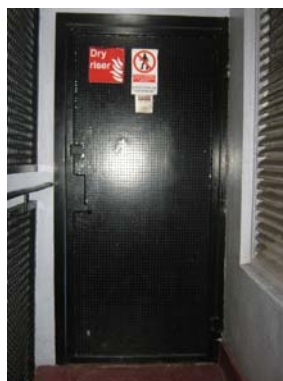
The doors to the lift motor rooms should have safety signage attached to ensure that personnel working within them can escape quickly, the door from the roof should have similar signage indicating both that it is a fire exit route and that it should be kept clear on the inside.

The door leading from the cat ladder to the stair lobby also has no signs indicating that it is a fire escape and thus should be kept clear.
