# London Borough of Hammersmith and Fulham

## Fire Risk Assessment

<b>Building:</b>	Shepherds Court
<b>Address:</b>	Shepherds Bush Green
<b>Post Code:</b>	W12 8PN

<b>Name of Assessor:</b>	Stephen Price
<b>Date of Assessment:</b>	14th June 2012
<b>Date of Next Review:</b>	13th June 2013

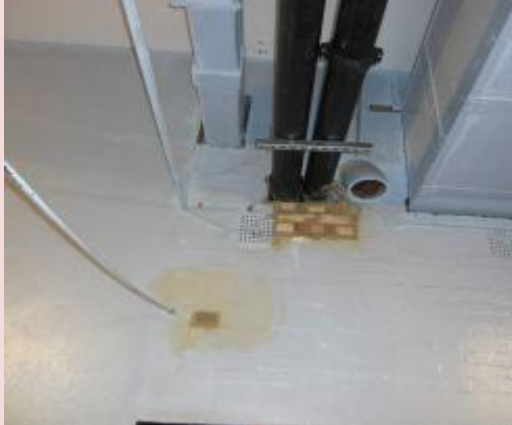
Picture Number	Picture	Brief Description
1

Services breaching compartment wall ground floor
2

Building	Address	Post Code	Code	Recommendation	Location	Risk Assessment Rating	Comp Date by LBHF
			TD13				
			TD14				
			TD15				
			TD16				
			TD17	It should be ensured that services are fully stopped where they breach the compartment wall at ground floor level.	Ground floor service area	6	
			C01	Investigate mechanical bathroom and kitchen extract systems to ensure that adequate compartmentation and fire stopping is provided to prevent the spread of smoke between flats. It should be ensured that walls between the flats and the shafts are adequately fire resisting and that the ventilation system itself is a 'shunt duct' system. If found to not be a shunt duct system, consider fitting intumescent fire dampers to the vents into the ducts.	General	6	
			C02				
			C03				
			C04				
			C05

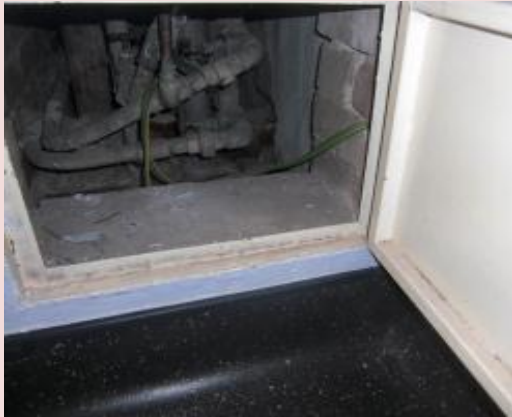
Example of cupboard outside flat
3

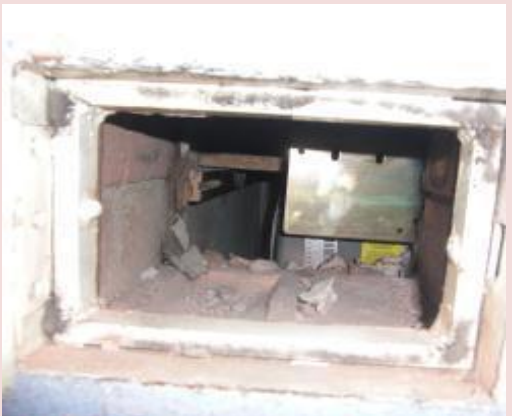
Meter reading point outside flat 24. Glazing missing
