fire risk assessments

shepherds court and bush court, charecroft estates off shepherds
bush green, london w12 8ra

October 2009

hunters

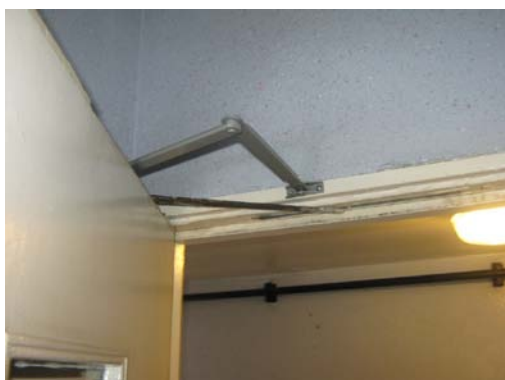
Not all original closers have been removed, thus some doors have 2 closers attached.

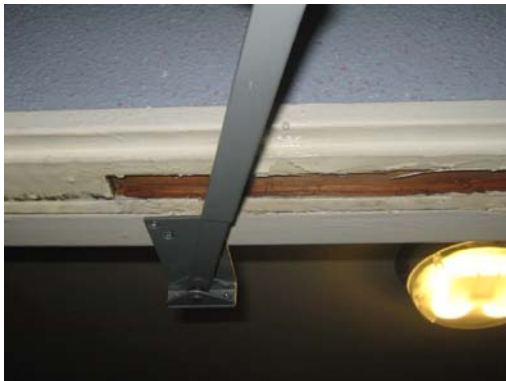
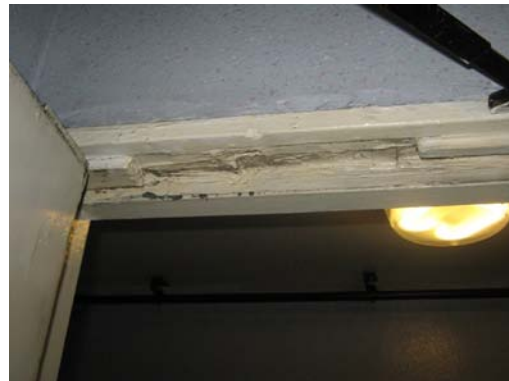
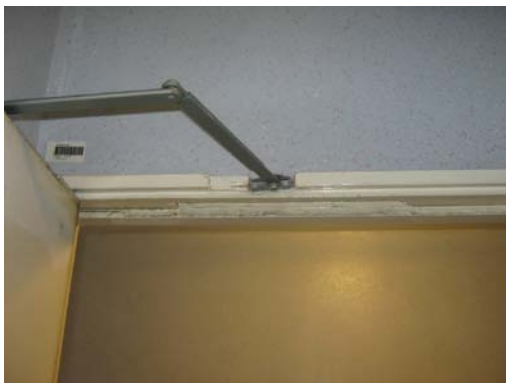
Where original closers have been removed there are rebates in both the tops of doors and in the heads of doorframes. Some of these have been inexpertly filled, others left

and, in at least one instance, part of the door closer remains in the top of the door. In any renovation of the doors, these rebates will need to be made good.

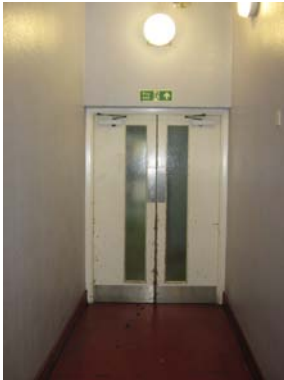
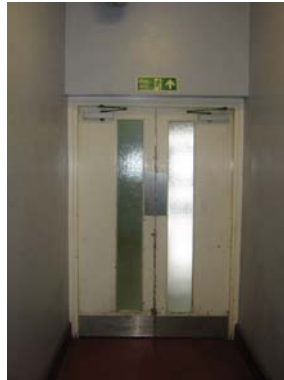
Between the bottom of the stairs and the lift lobby is a set of double opening doors. These are in serviceable condition but it is unlikely that they will provide fire or smoke protection to the escape route. They can be upgraded by the fitting of smoke seals but, as with the lobby/stair doors; no guarantee of performance can be given. These doors should, therefore, also be considered for replacement by a new doorset.

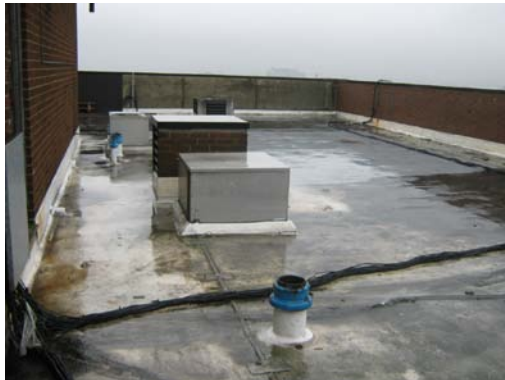
At the time of this inspection there was very little rubbish on the roof merely some old conduit and lengths of timber.

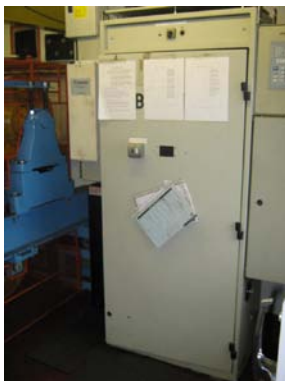
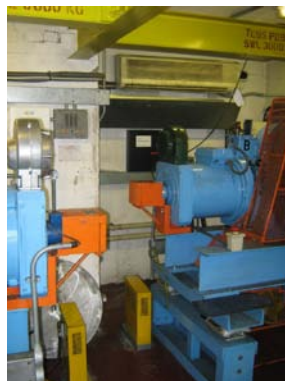
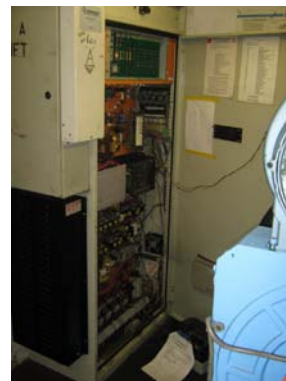
There is no fire detection within the lift motor rooms, but the rooms were both tidy and clean with rubber mats on the floor in front of electrical equipment. They were let down by the lack of serviced fire extinguishers and by the open cabinet to Lift A in Bush Court.

As a general policy, remote, high risk areas should be considered for fire detection when determining whether a system is to be installed within the building.
